## My Safe Home Inspection

### All space storage, inc. (bob brozman, jr.)

5345 Burgess Ave  
Cocoa, Florida 32927

# Roof Condition Certification Form

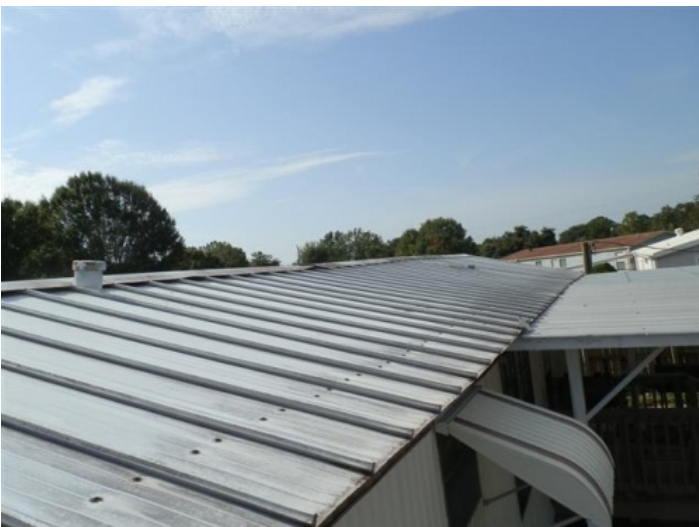
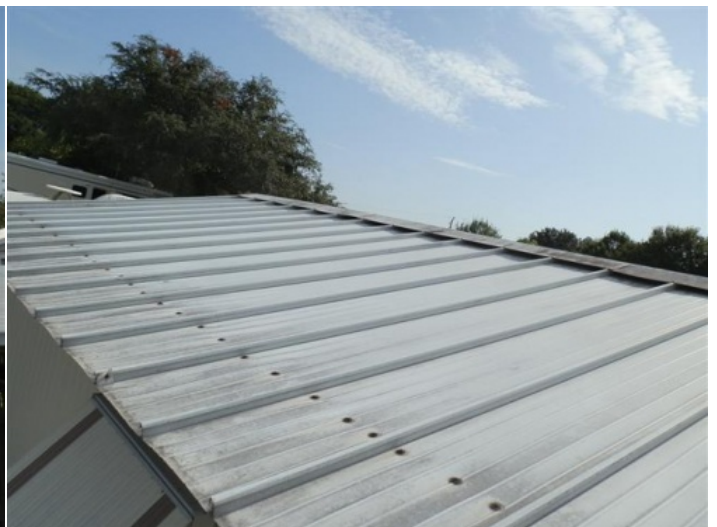
Roof Material: Metal, Front Slope

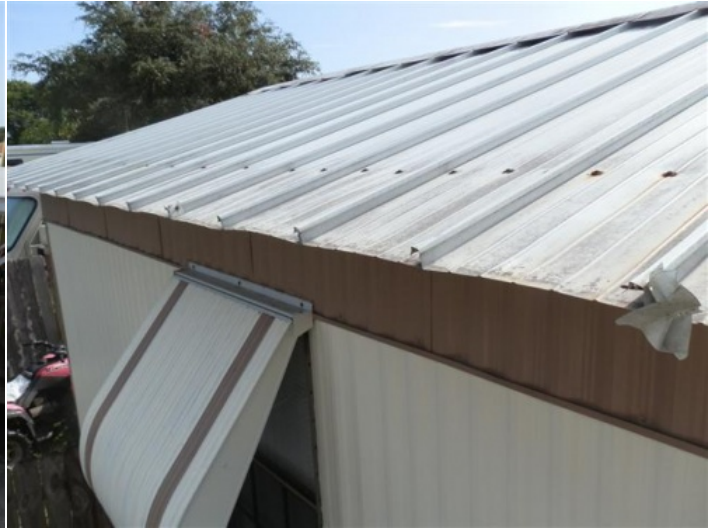
- No
- Yes, explain: The rear roof slope is bent at the end of the overhang but does not affect the roof to wall connection. The metal fascia has been removed.

Metal Fascia Has Been Removed

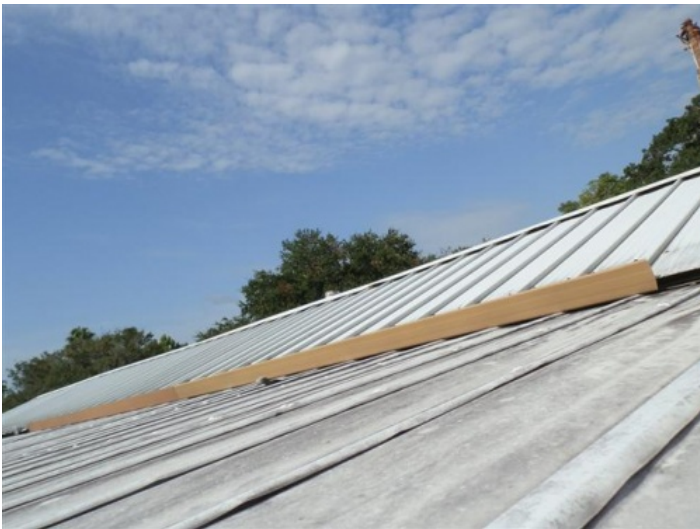
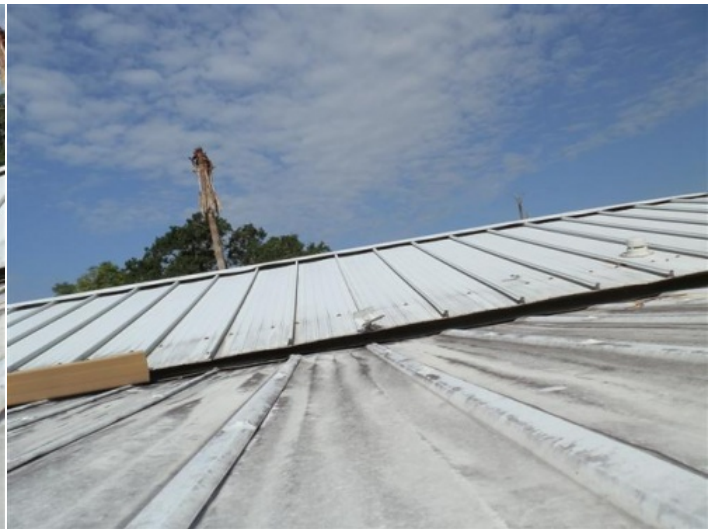
Roof Material: Metal, Rear Slope

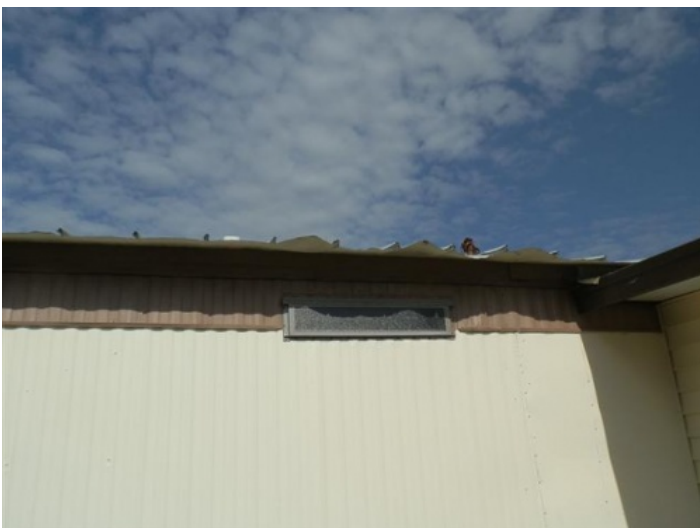
Roof Damage Observed
