My Safe Home Inspection

Legacy Four Point Report Summary

ADDRESS INSPECTED: 2010 Adams Ave , Melbourne, Florida, 32935

DATE INSPECTED: Sep 11, 2013, 10:00:00 AM

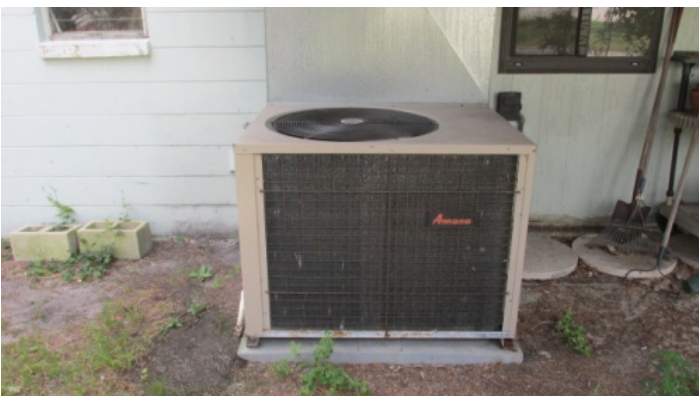
Package heating and cooling unit

Heating & AC package unit

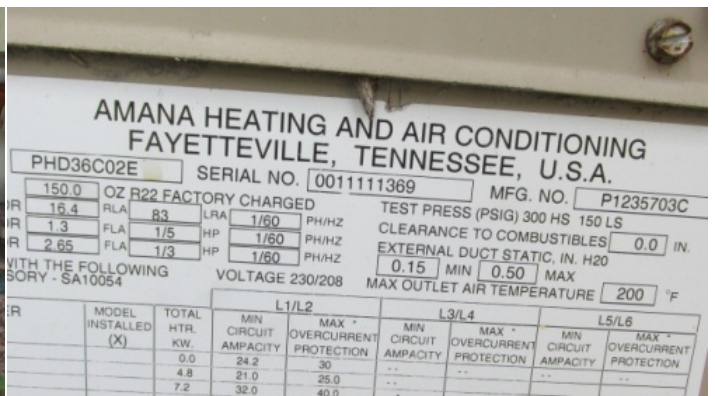
Heating & AC package unit label - mfg 2000

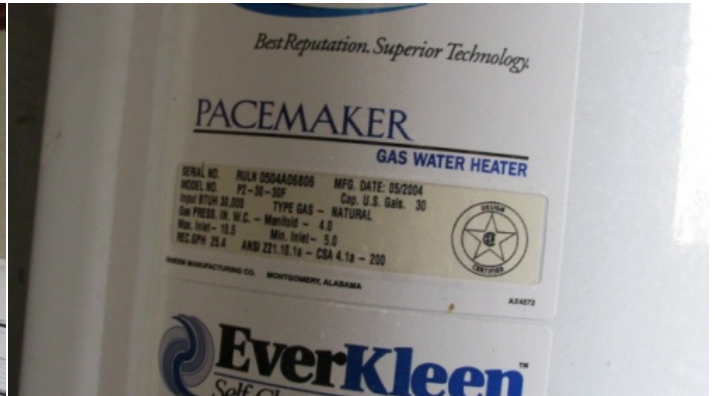
Water Heater label - mfg 2004

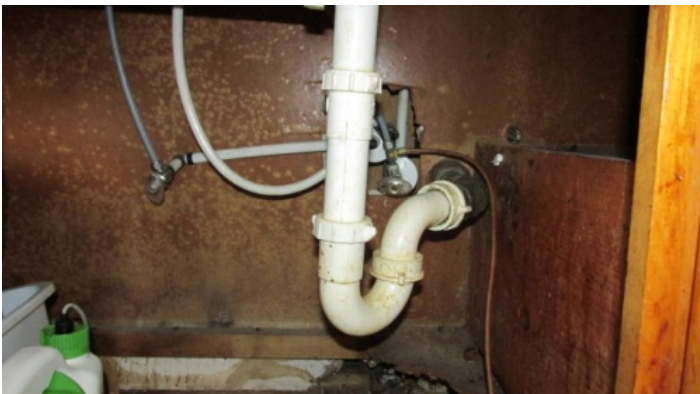
PEX water supply lines ran throughout home. No leaks observed at time of inspection. Shut off valves installed on all fixtures.

Kitchen Plumbing (under sink) - PEX water supply lines, PVC and galvanized drain

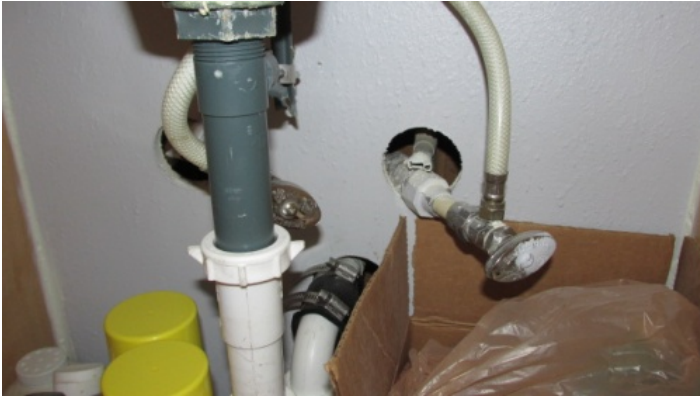
Bath Plumbing (under sink) - shut off valves, flex vinyl water supply lines

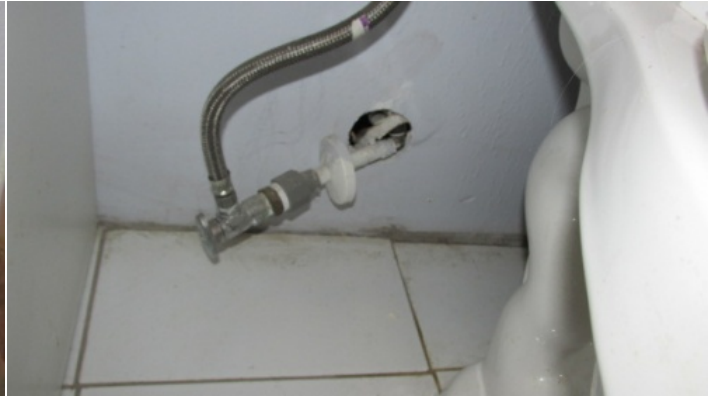
Toilet water shut off valve and flex metal water supply lines

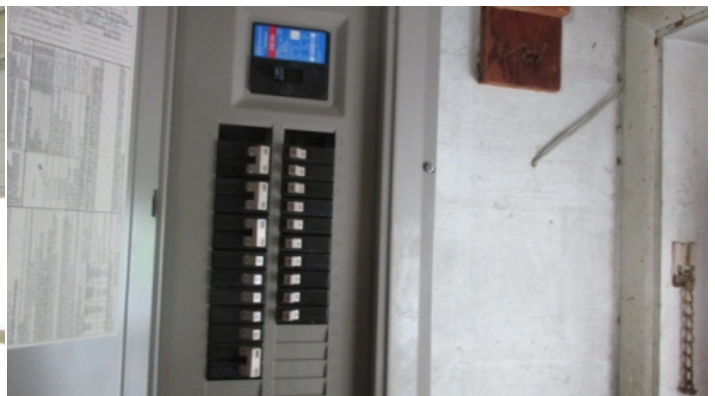
Electrical distribution wiring looked good. Panel has two missing blank plates at top.

Circuit breakers - panel wiring looked good

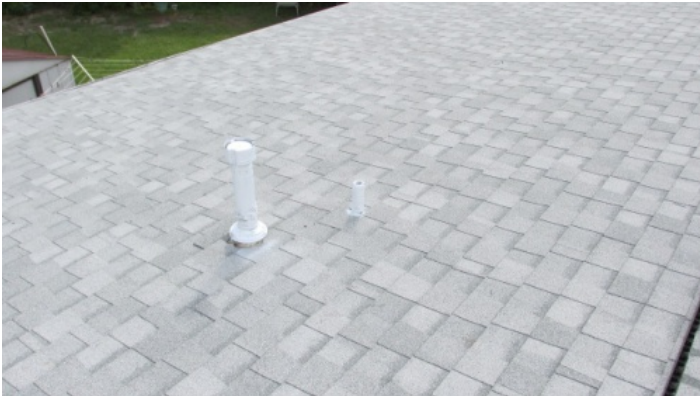
New roof recently installed.

Architectural shingle roof - 2013

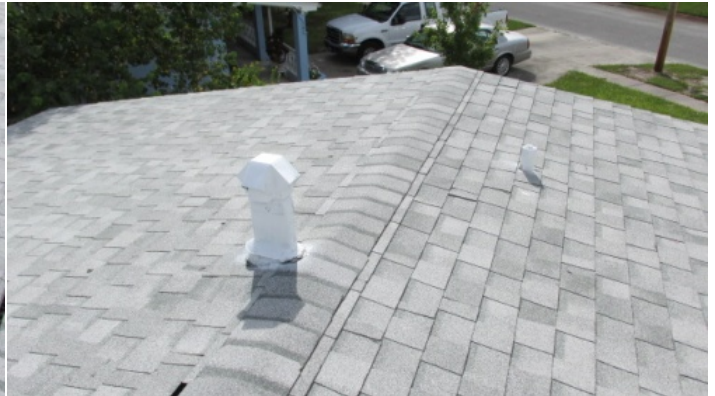
Roof penetrations looked good

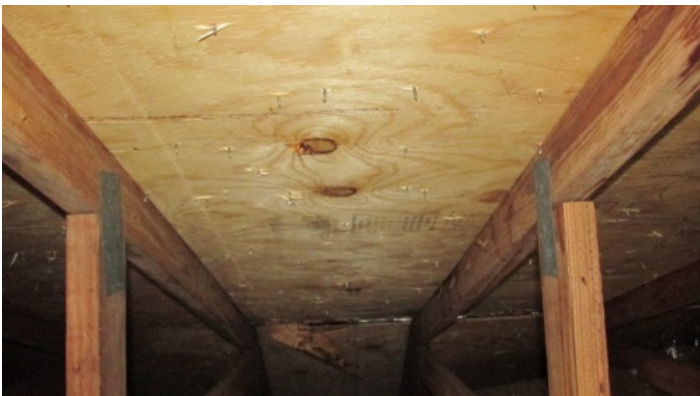
Roof Attic Sheathing - plywood
