My Safe Home Inspection

Legacy Four Point Report Summary

ADDRESS INSPECTED: 2010 Adams Ave , Melbourne, Florida, 32935

DATE INSPECTED: Sep 11, 2013, 10:00:00 AM

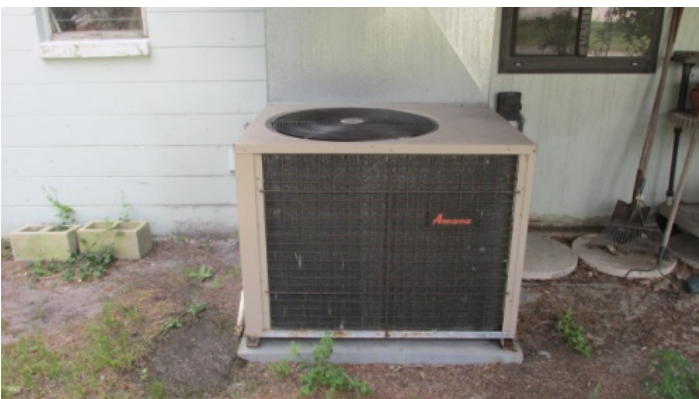
Heating & AC package unit

Package heating and cooling unit

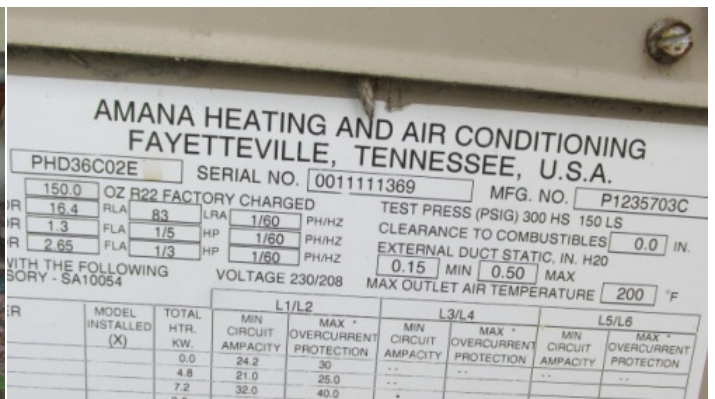
Heating & AC package unit label - mfg 2000

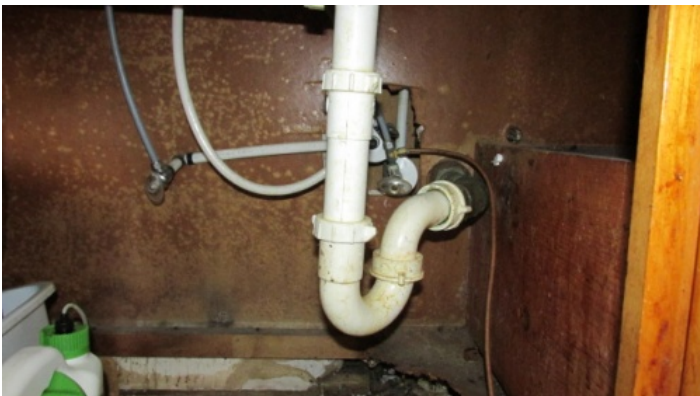
PEX water supply lines ran throughout home. No leaks observed at time of inspection. Shut off valves installed on all fixtures.

Kitchen Plumbing (under sink) - PEX water supply lines, PVC and galvanized drain

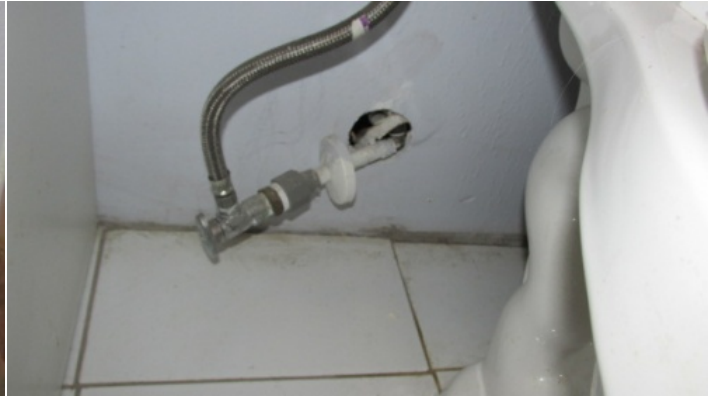
Toilet water shut off valve and flex metal water supply lines

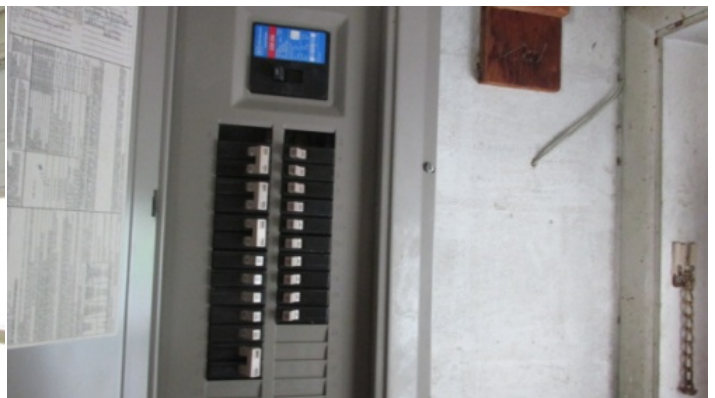
Electrical distribution wiring looked good. Panel has two missing blank plates at top.

Circuit breakers - panel wiring looked good

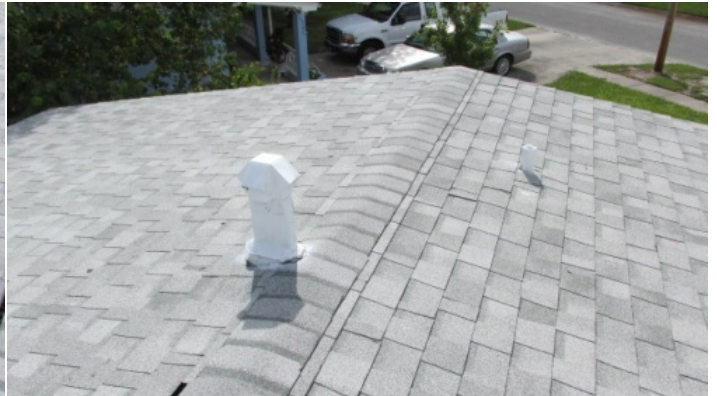
Roof penetrations looked good
