My Safe Home Inspection

Legacy Four Point Report Summary

ADDRESS INSPECTED: 2010 Adams Ave , Melbourne, Florida, 32935

DATE INSPECTED: Sep 11, 2013, 10:00:00 AM

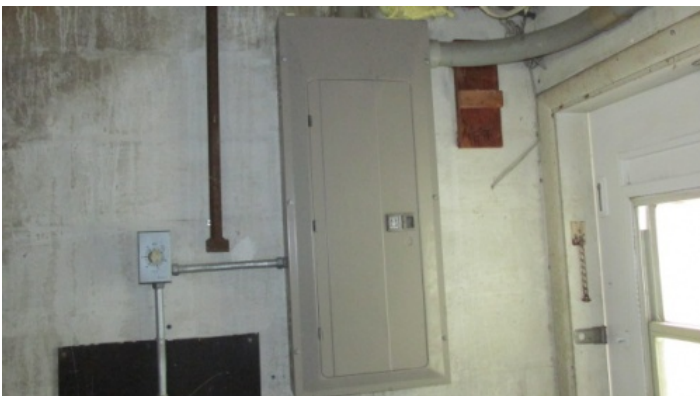
Electrical Distribution Panel (cover on)

Electrical distribution wiring looked good. Panel has two missing blank plates at top.
